Home Inspection Report

1234 S. Main Street
Anytown, FL 00000

Prepared for: Home Buyer

Prepared by: Sharp Home Inspections, Inc.
PO Box 20934
Bradenton, FL 34204

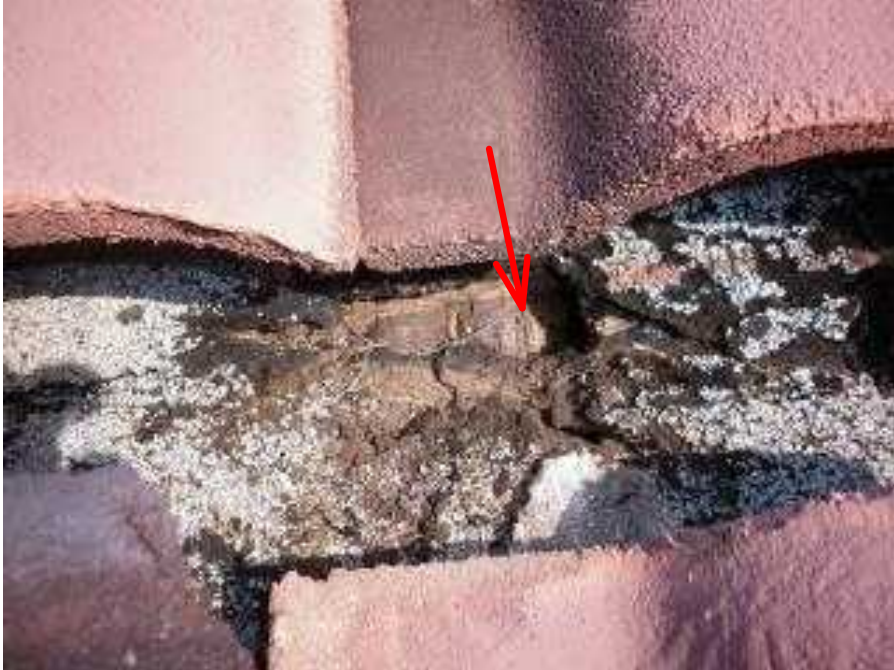
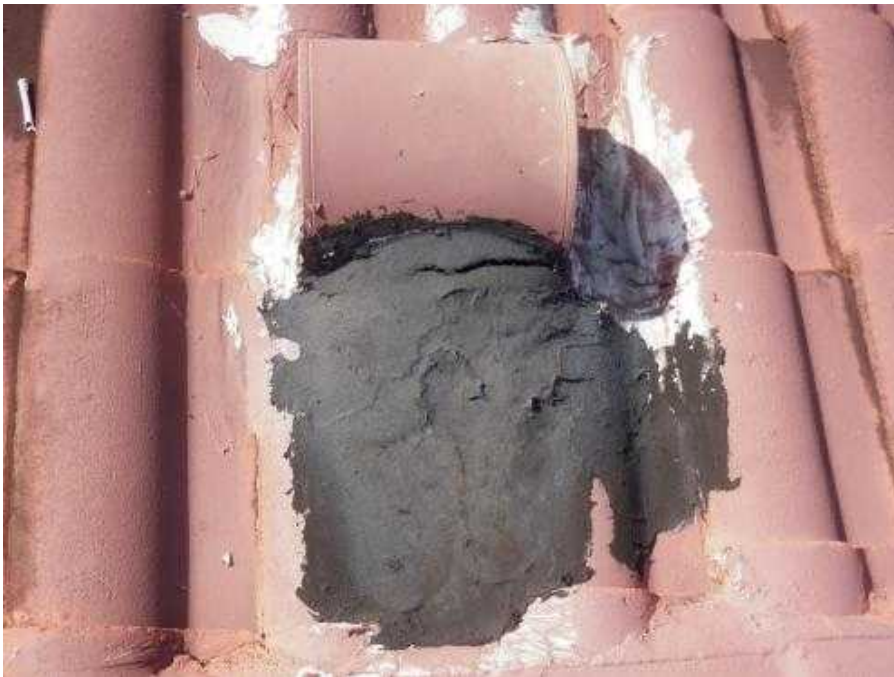
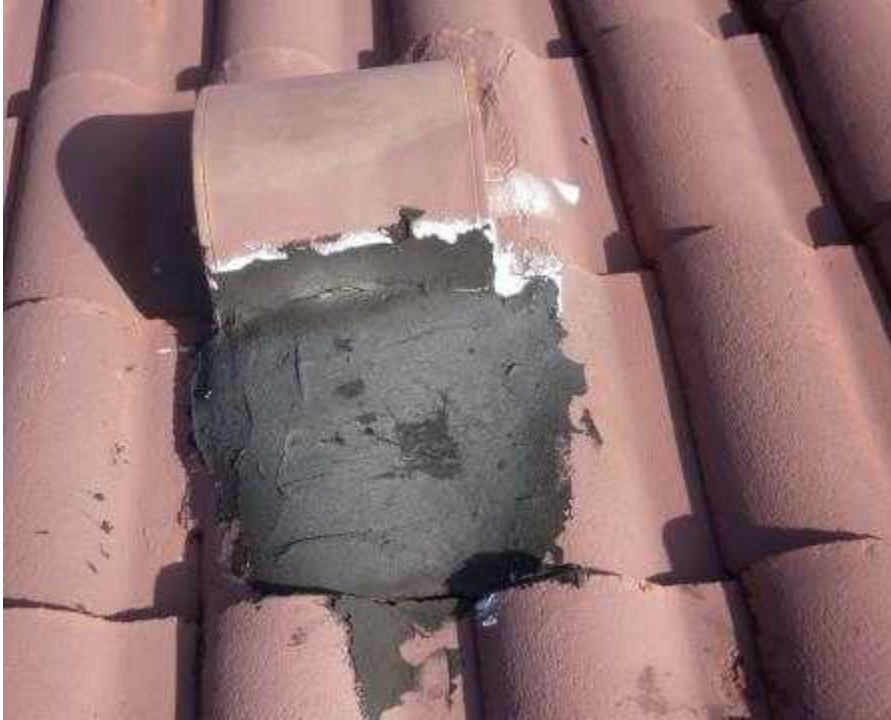
- 1. Main Roof Surface Material:** Cement tile. Plywood has deteriorated and waterproofing membrane is worn to area over carport utility room. Evidence of leaks visible in attic area. Repairs noted to areas around roof vents. Recommend further evaluation and cost of repair or replacement of roof by a licensed roofing contractor. See additional comments and photos under attic section of report.

Material: Cement tile. Plywood has deteriorated and waterproofing membrane is worn to area over carport utility room. Evidence of leaks visible in attic area. Repairs noted to areas around roof vents. Recommend further evaluation and cost of repair or replacement of roof by a licensed roofing contractor. See additional comments and photos under attic section of report.

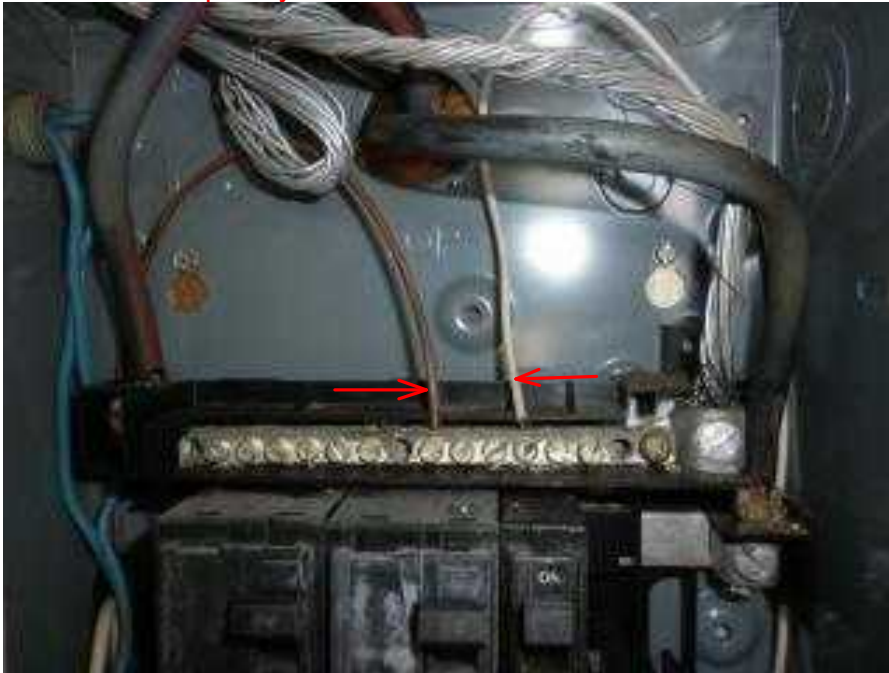
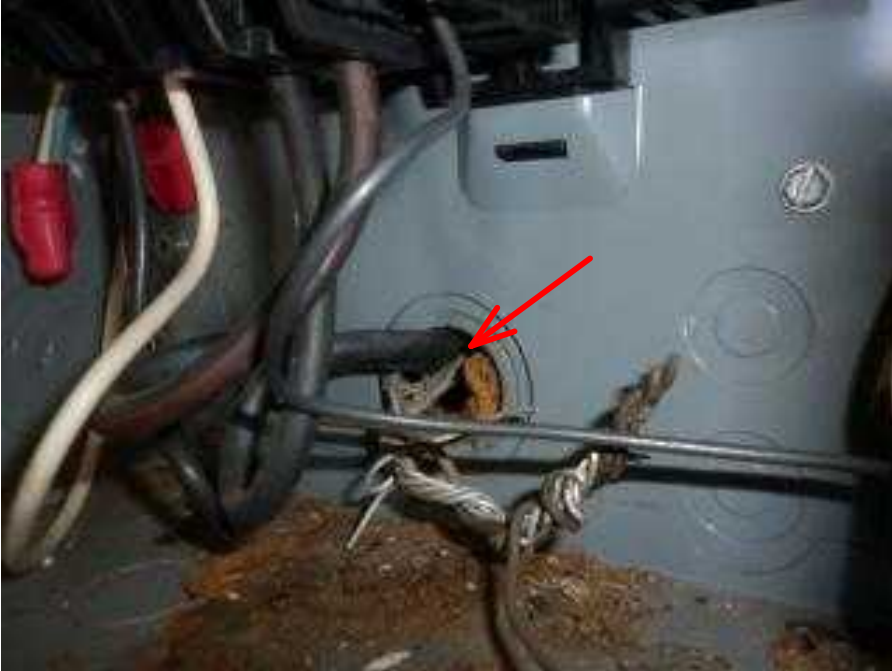
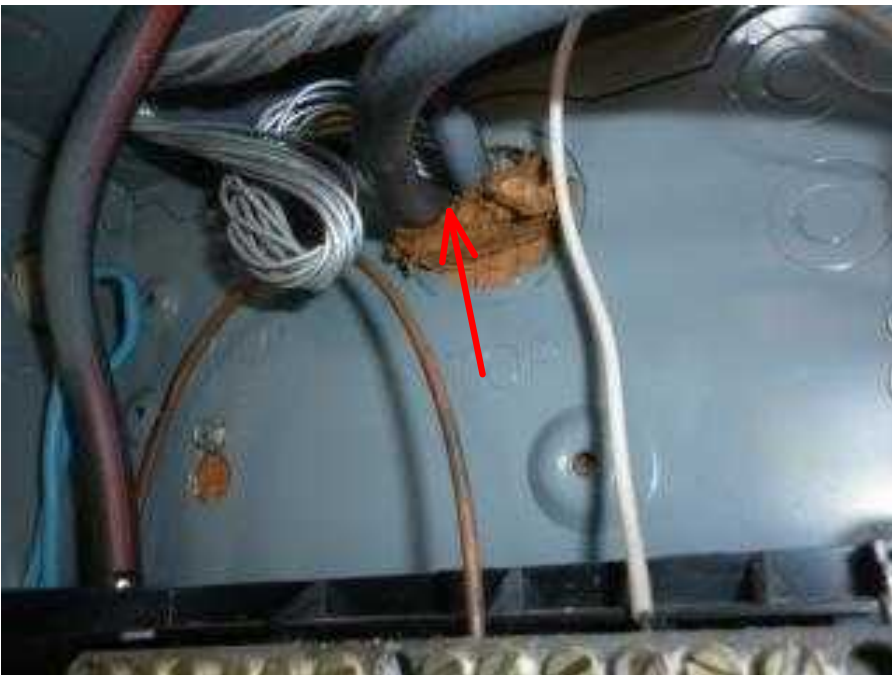
- 2. Smoke Detectors:** Not present. Recommend installing smoke detectors for safety
- 3. Carport Closet Electric Panel Manufacturer:** Square D. Ground and neutral wires need to be isolated on the sub panel, cannot be on the same bus bar. Additionally, wires entering panel at top and bottom of the panel are not protected by NM connectors to prevent wires from been pulled out or cut by sharp edges of panel. Recommend repair by a licensed electrician.

Manufacturer: Square D. **Ground and neutral wires need to be isolated on the sub panel, cannot be on the same bus bar. Additionally, wires entering panel at top and bottom of the panel are not protected by NM connectors to prevent wires from been pulled out or cut by sharp edges of panel. Recommend repair by a licensed electrician.**

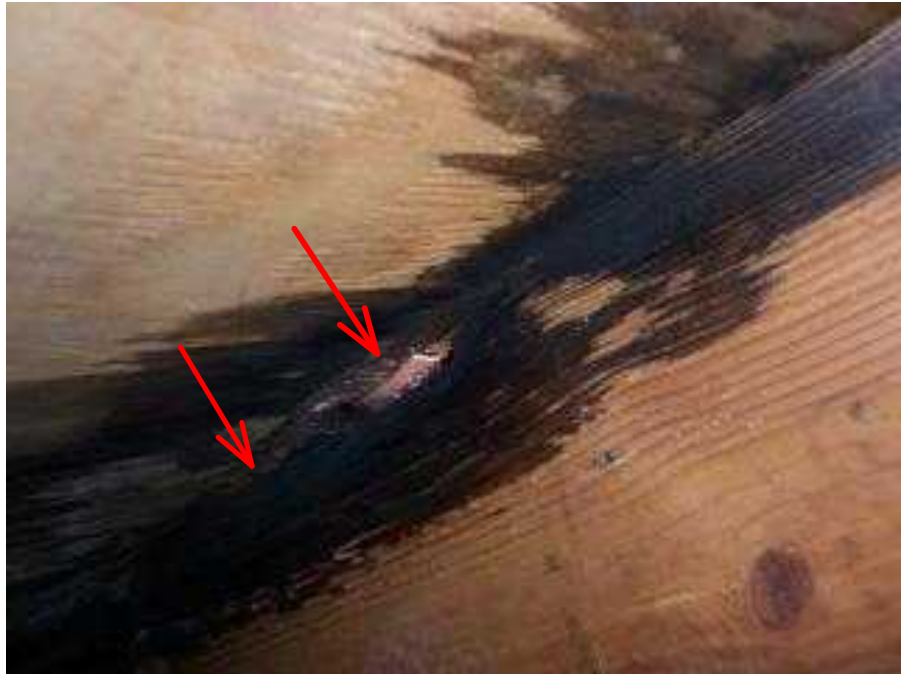
- 4. Main Attic Roof Framing:** Truss. Water damage to top of rafter, recommend further evaluation and repair by a licensed roofing contractor
- 5. Main Attic Sheathing:** Plywood. Water damage to plywood sheathing in several areas. Recommend further evaluation and cost of repair or replacement of roof by a licensed roofing contractor.

- Unable to Inspect:** 30%
- Roof Framing:** Truss. **Water damage to top of rafter, recommend further evaluation and repair by a licensed roofing contractor**

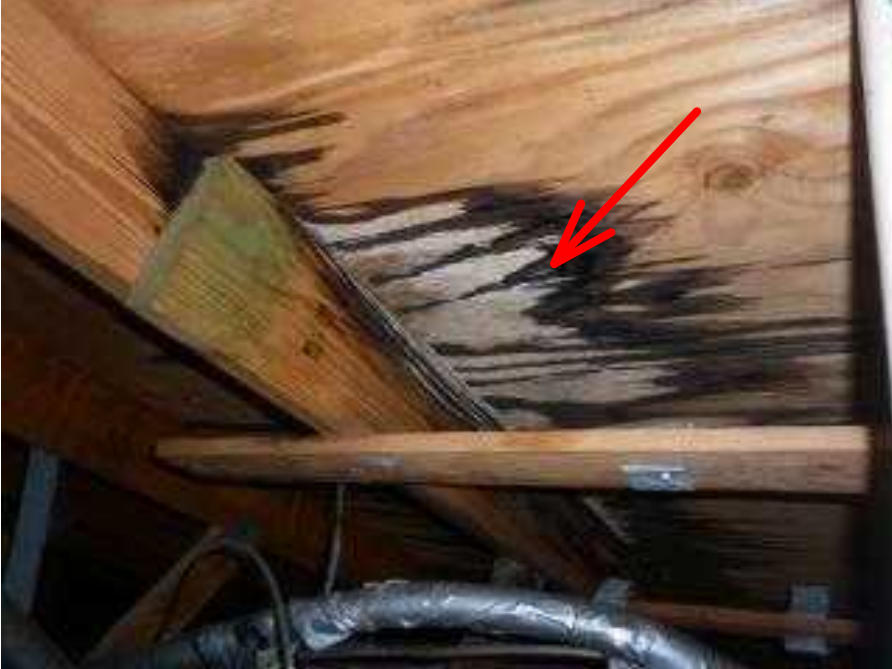
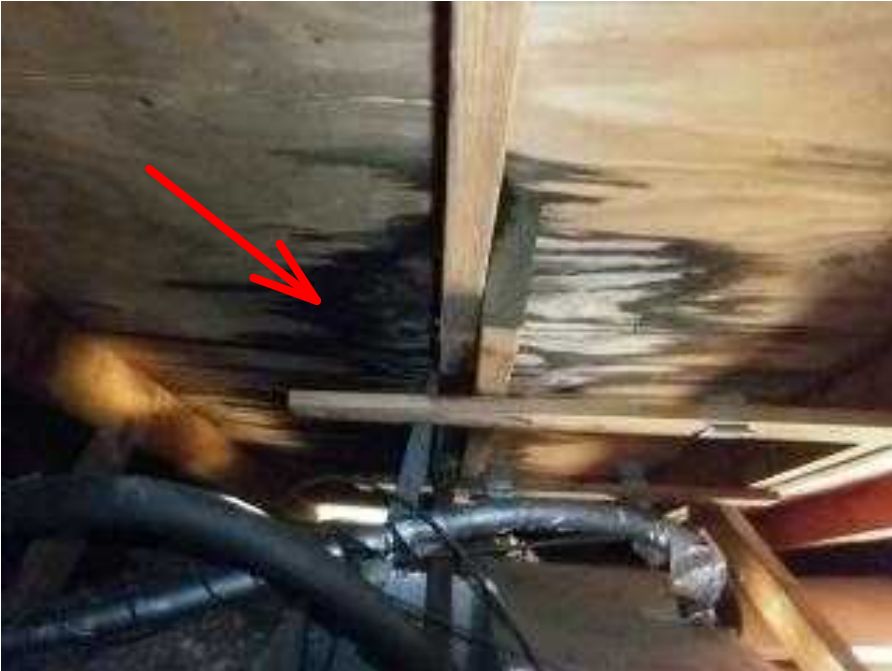
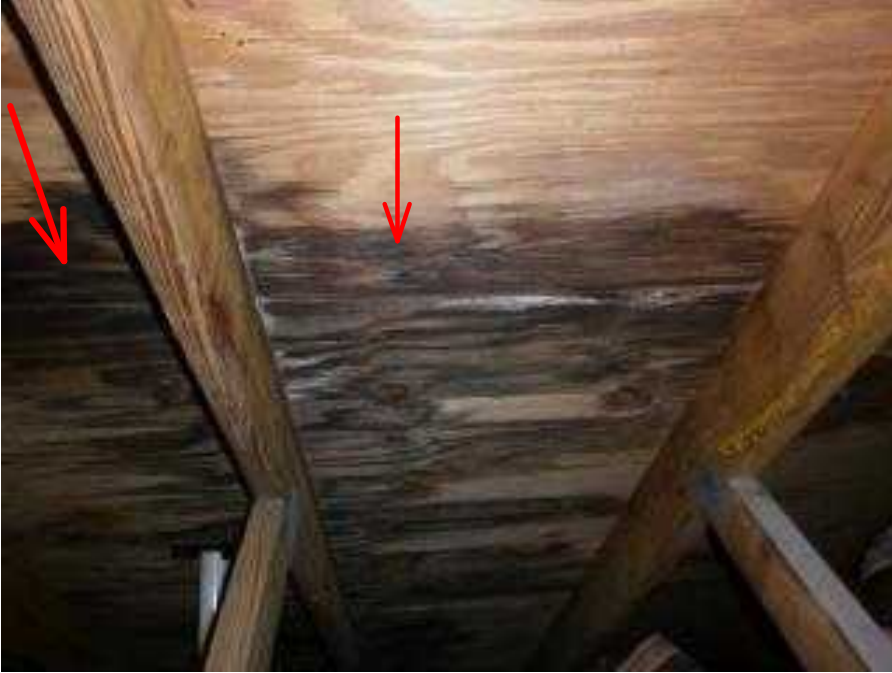
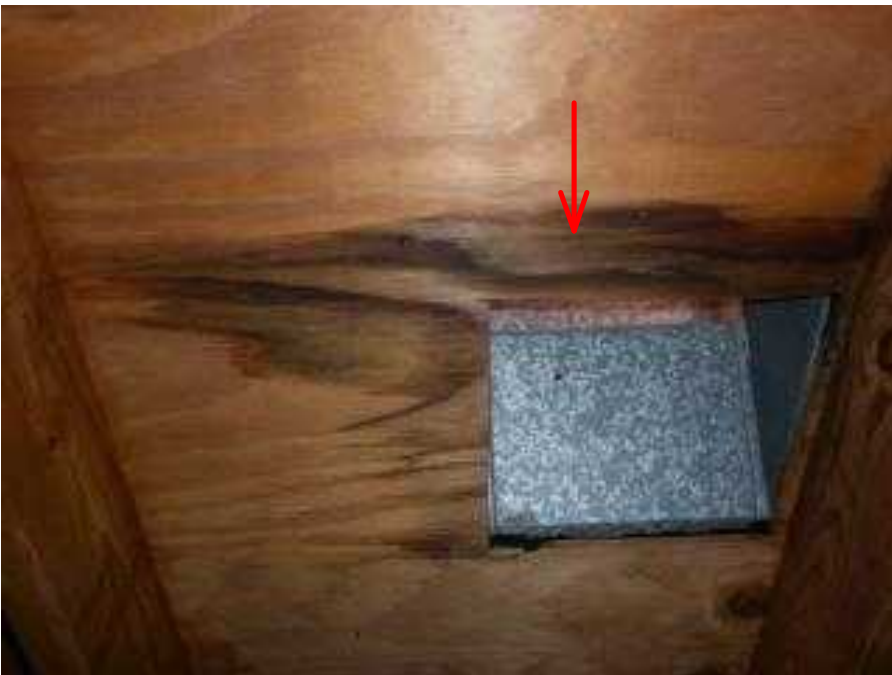
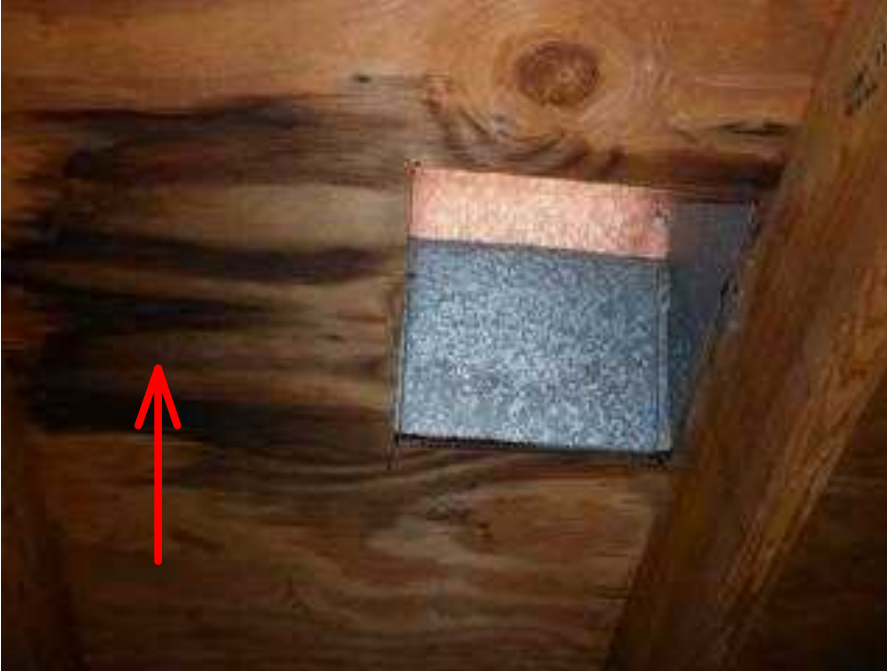
Sheathing: Plywood. Water damage to plywood sheathing in several areas. Recommend further evaluation and cost of repair or replacement of roof by a licensed roofing contractor.

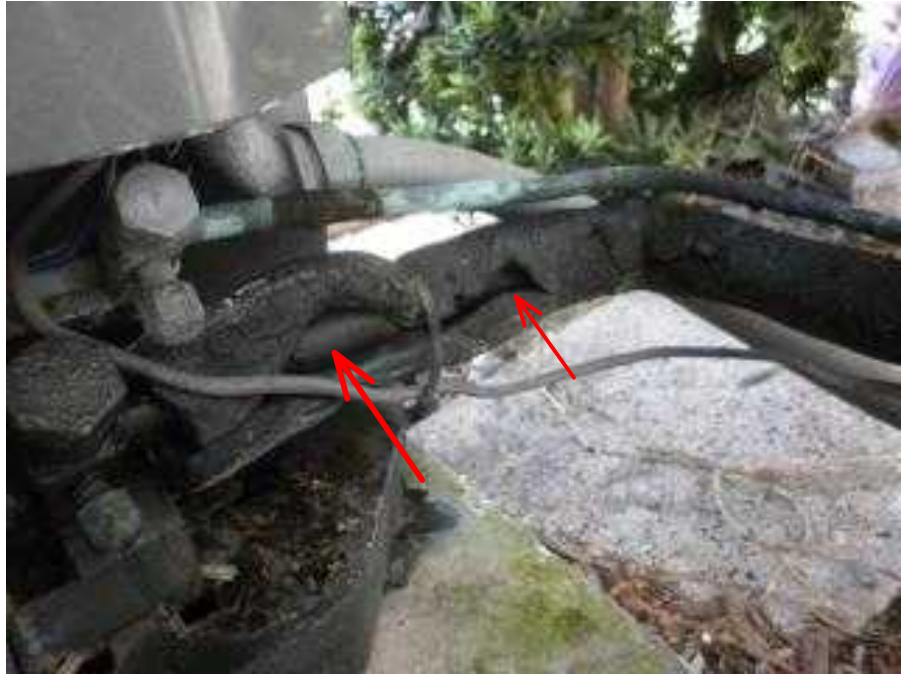
- 6. Right Side of Home AC System Refrigerant Lines:** Serviceable condition. Torn and missing insulation around refrigerant lines, recommend replacing

- Refrigerant Lines:** Serviceable condition. **Torn and missing insulation around refrigerant lines, recommend replacing**

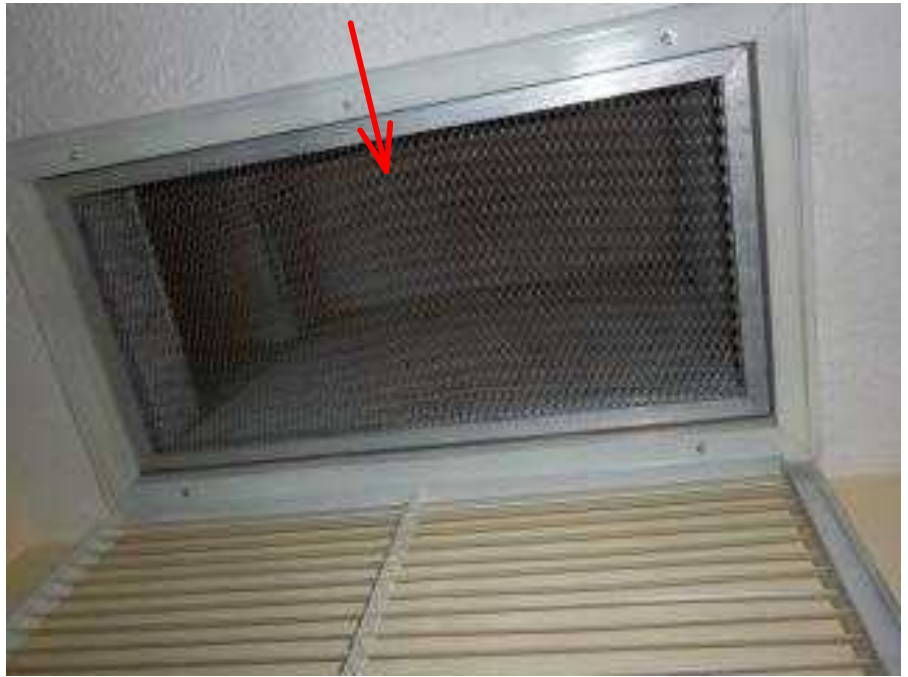
- 7. Right Side of Home Heating System Blower Fan/Filter:** Direct Drive. No filter installed in air handler or return air duct. Recommend installing correctly sized filter and replacing / washing on a regular basis.

- Blower Fan/Filter:** Direct Drive.
No filter installed in air handler or return air duct. Recommend installing correctly sized filter and replacing / washing on a regular basis.

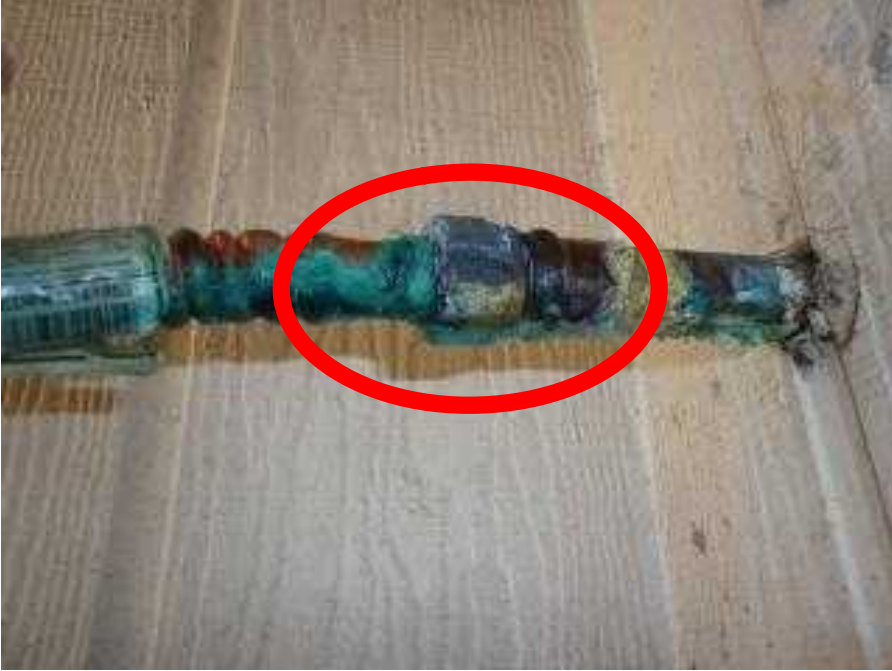
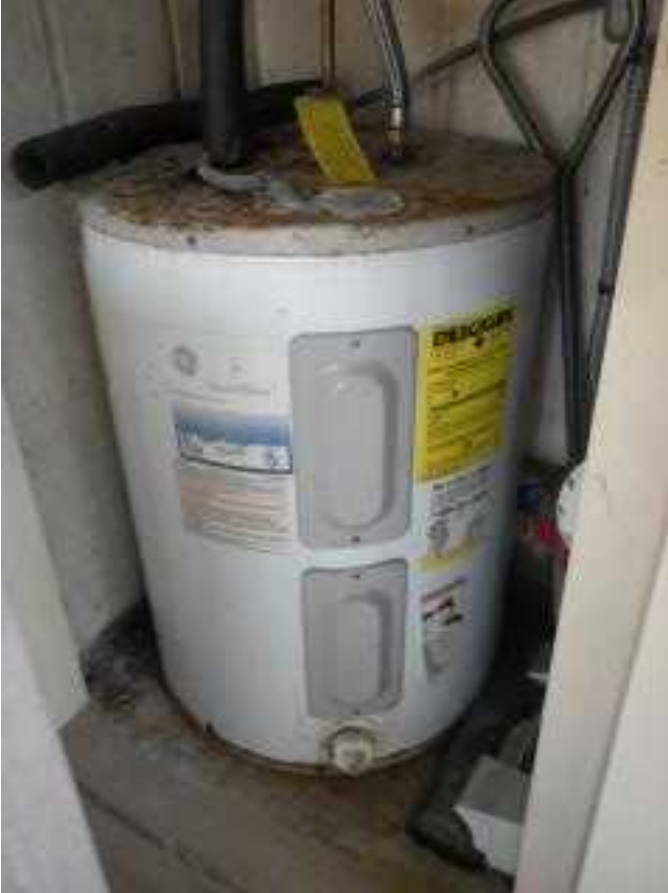
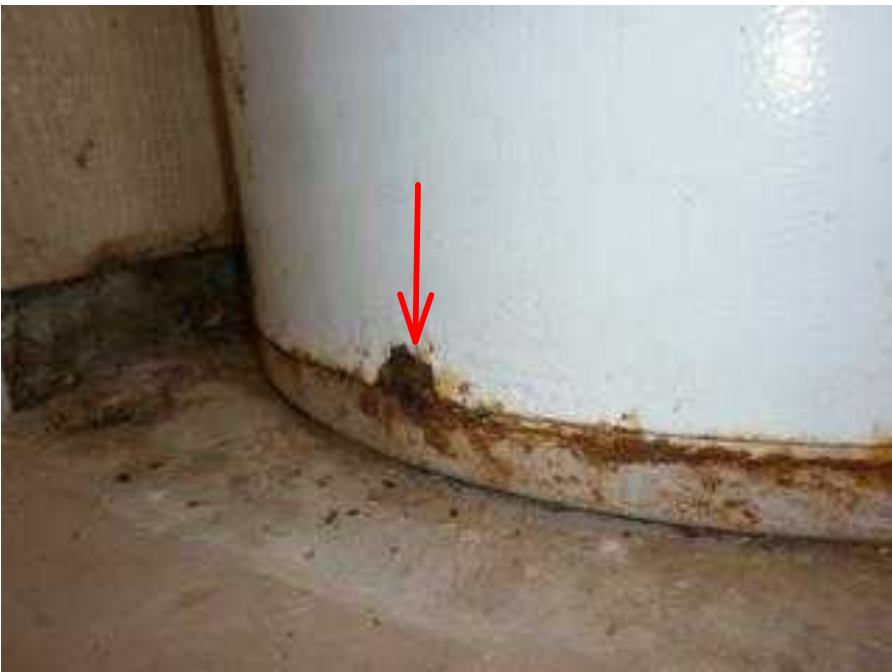
- 8. Carport Closet Water Heater Water Heater Operation:** Functional at time of inspection. Active leak at pipe above water heater. Recommend repair by a licensed plumber. Evident of rust noted to top and bottom of water heater casing.
- 9. Carport Closet Water Heater TPRV and Drain Tube:** Copper. TPRV drain line has been reduced, may pose a safety hazard in the event of a malfunction, recommend installing a 3/4" drain line as per manufacturer's specifications

- Water Heater Operation:** Functional at time of inspection. **Active leak at pipe above water heater. Recommend repair by a licensed plumber. Evident of rust noted to top and bottom of water heater casing.**

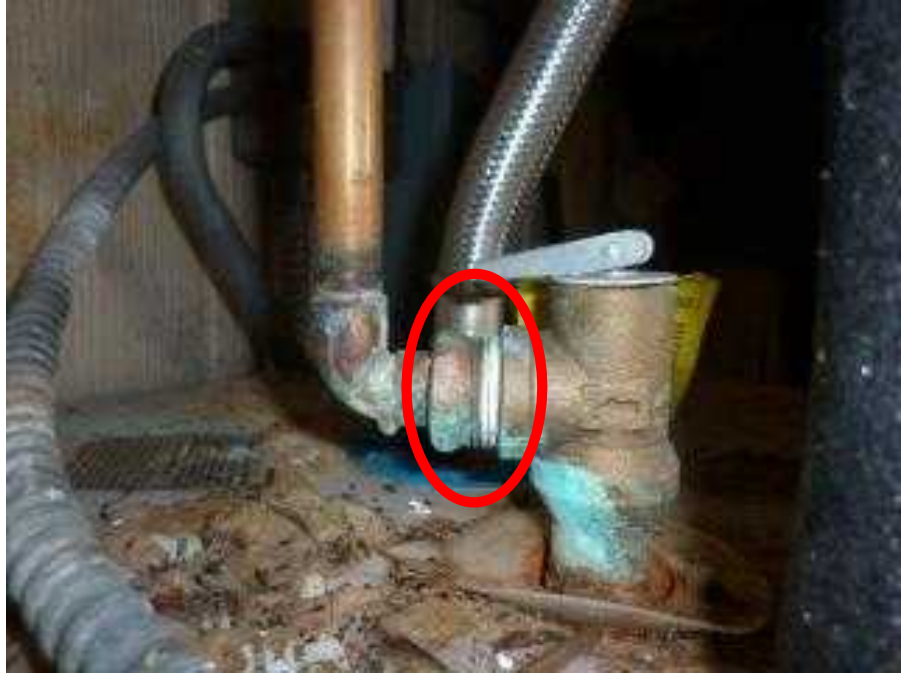
TPRV and Drain Tube: Copper.

TPRV drain line has been reduced, may pose a safety hazard in the event of a malfunction, recommend installing a 3/4" drain line as per manufacturer's specifications

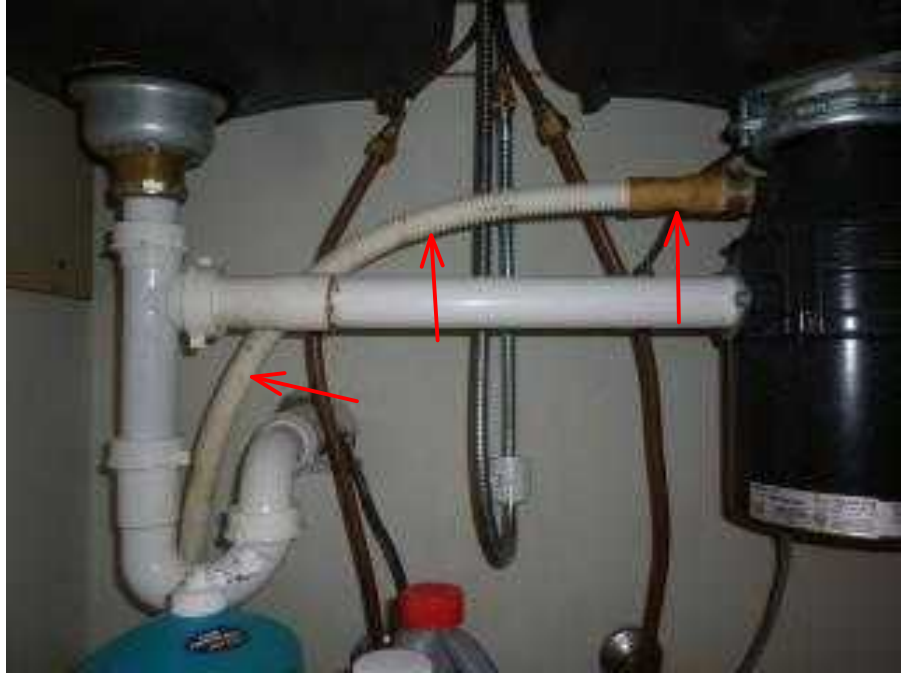
- 10. Main Kitchen Air Gap Present?** No . Drain line from washer connected to lower end of disposal, which will allow wastewater to flow into dishwasher in the event of a blockage in sink. Drain line should have an air gap or be looped in a high arc under the countertop as an alternative. See <http://www.home-inspect.com/itatis/04-03.asp> for further information.
- 11. Main Kitchen Refrigerator:** Hotpoint. Icemaker did not produce ice during the time of the inspection. Recommend further evaluation by a technician to verify proper operation

Air Gap Present? Yes No . Drain line from washer connected to lower end of disposal, which will allow wastewater to flow into dishwasher in the event of a blockage in sink. Drain line should have an air gap or be looped in a high arc under the countertop as an alternative. See <http://www.home-inspect.com/itatips/04-03.asp> for further information.

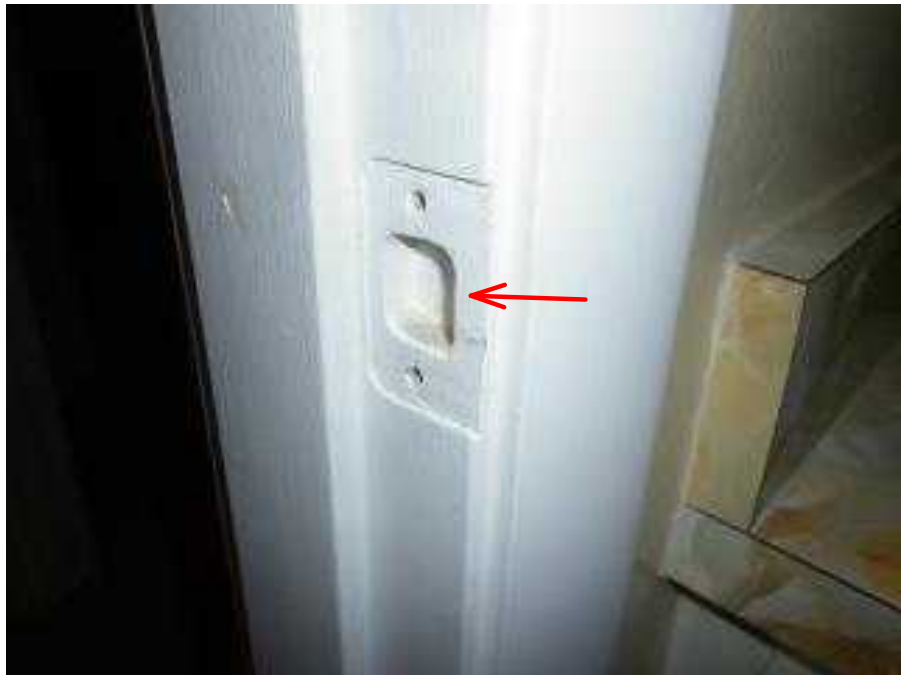
- Ceiling:** Popcorn ceiling
- Walls:** Painted drywall
- Floor:** Ceramic tile
- Doors:** Hollow wood. [Striker plate missing at door.](#)

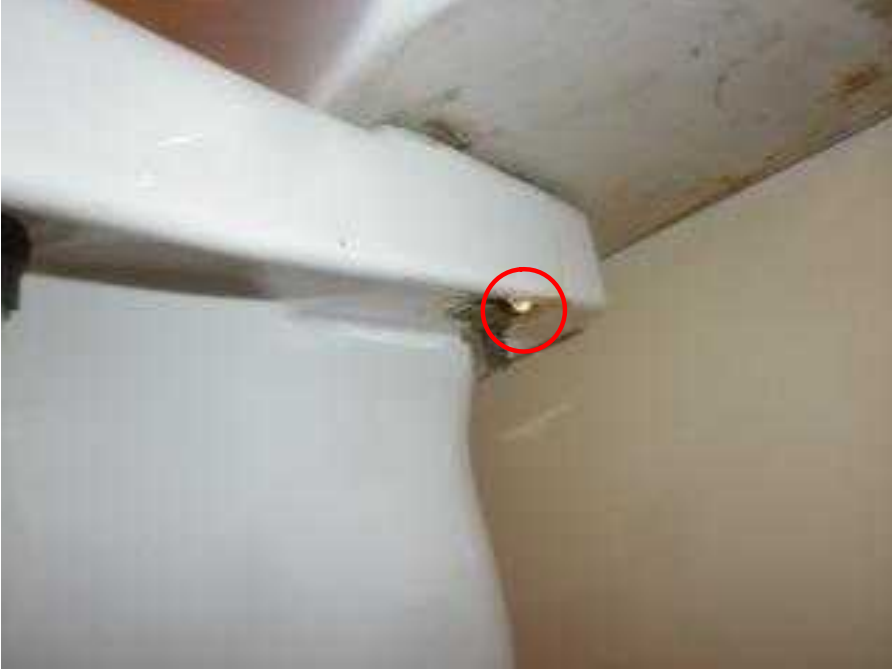
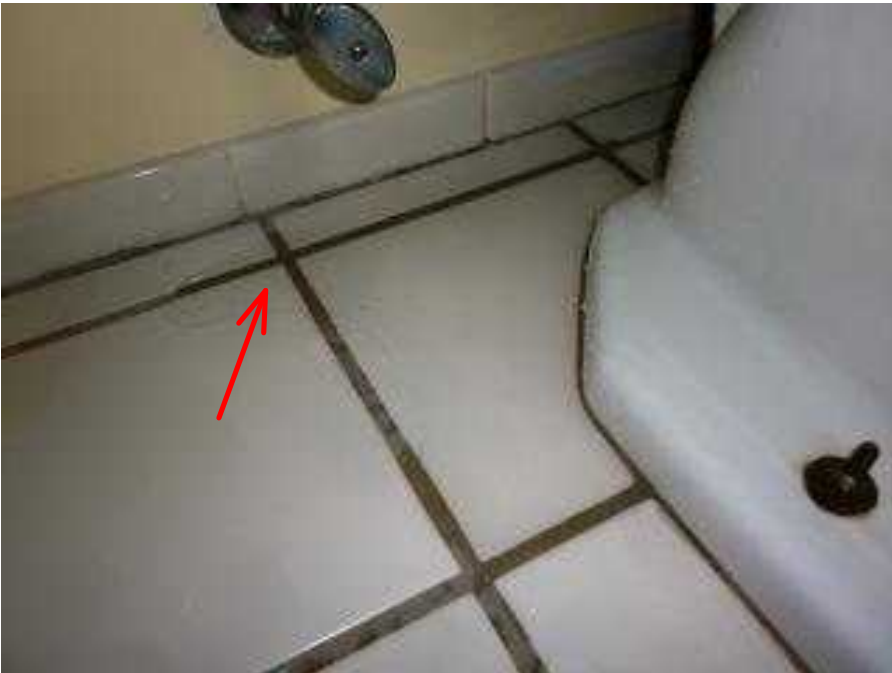
- 12. Bathroom 2 Bathroom Toilets:** Gerber. Leak at toilet tank when unit is flushed. Recommend repair by a licensed plumber.

Toilets: Gerber. **Leak at toilet tank when unit is flushed. Recommend repair by a licensed plumber.**

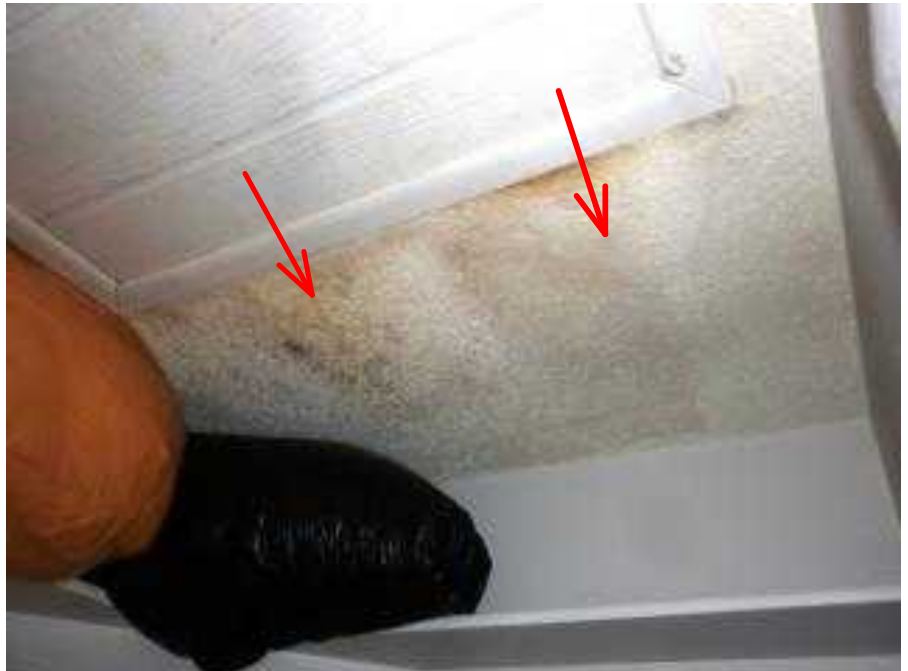
- 13. Master Bedroom Closet:** Walk In. Water stains noted. No moisture present at the time of inspection.
- 14. Bedroom 2 Bedroom Electrical:** 110 VAC outlets and lighting circuits. Ceiling light and a fan was inoperative, possibly bad battery in remote control. Recommend further evaluation by a licensed electrician.

Closet: Walk In. **Water stains** noted. No moisture present at the time of inspection.

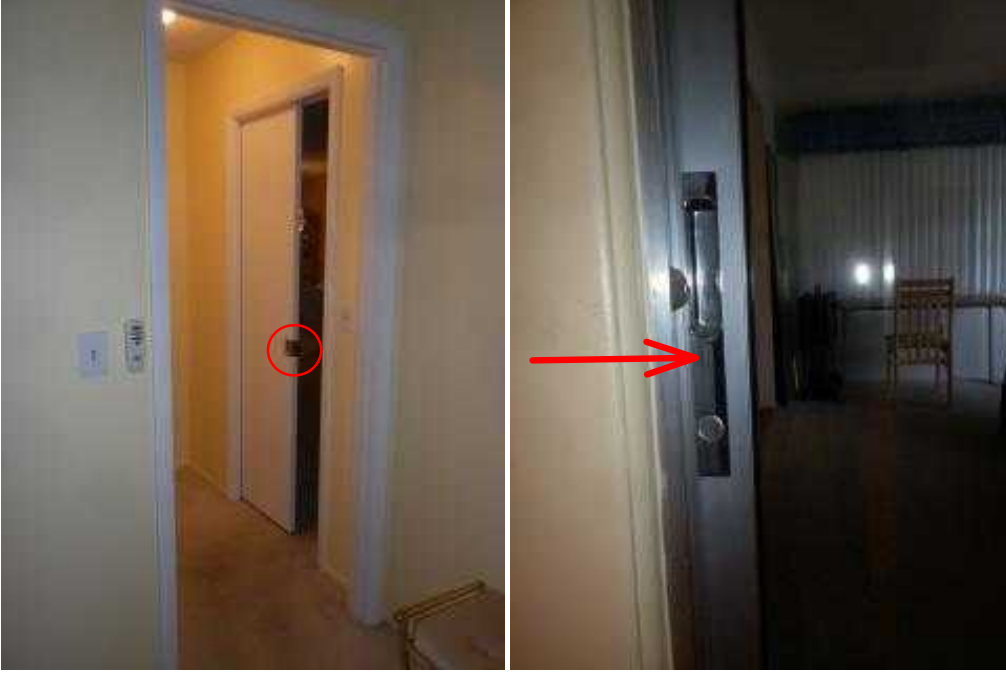
Doors: Hollow wood, Sliding Glass. Door to bedroom has been removed, pocket door to bedroom hallway does not lock. Glass sliding door also has no lock.

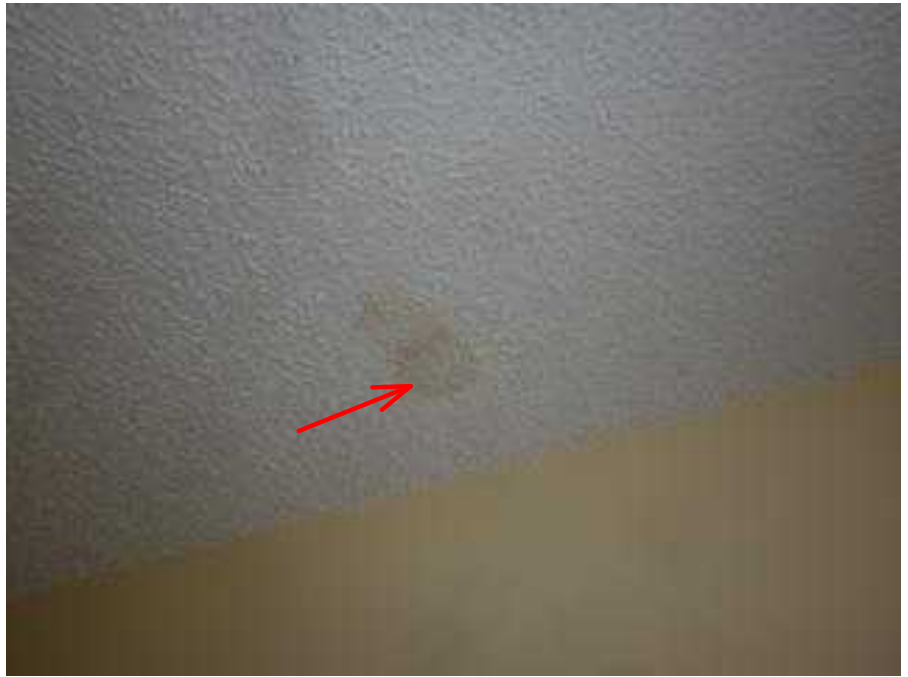
Ceiling: Popcorn ceiling. [Water stain to ceiling.](#)

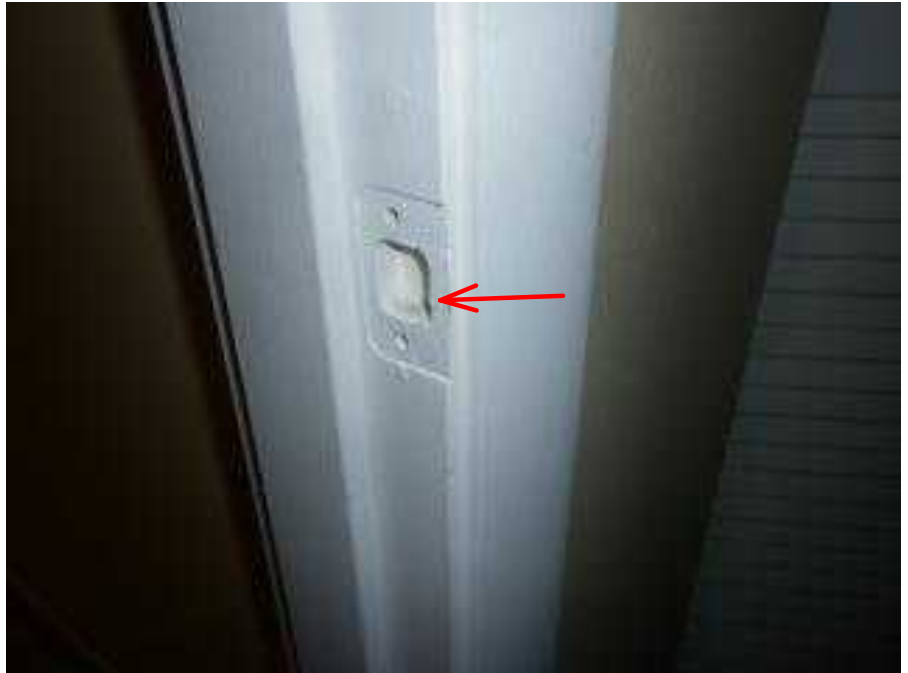
Doors: Hollow wood. [Striker plate missing at door.](#)

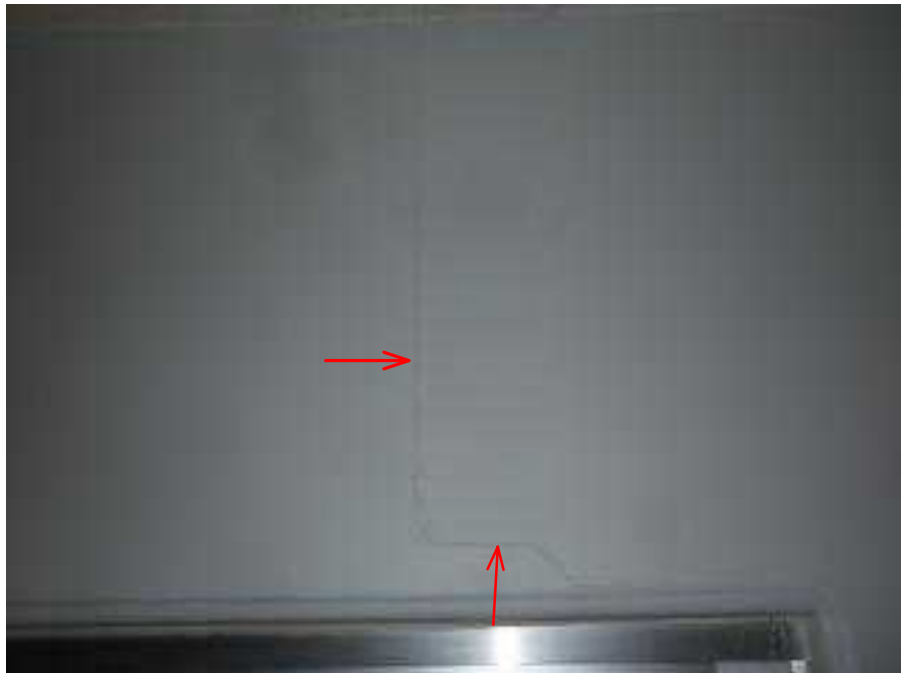
- Ceiling:** Popcorn ceiling
- Walls:** Painted drywall. *Minor hairline crack to south wall, above sliding glass door*

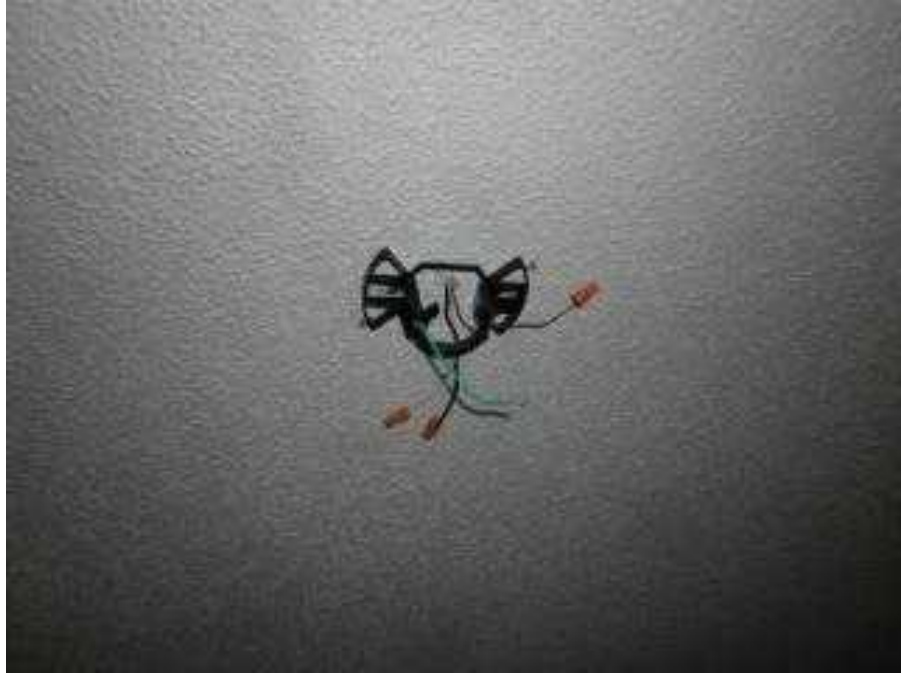
- 15. Den Living Space Electrical:** 110 VAC outlets and lighting circuits. Ceiling light fixture missing.

- Floor:** Carpet
- Doors:** French
- Windows:** Aluminum awning
- Electrical:** 110 VAC outlets and lighting circuits. **Ceiling light fixture missing.**

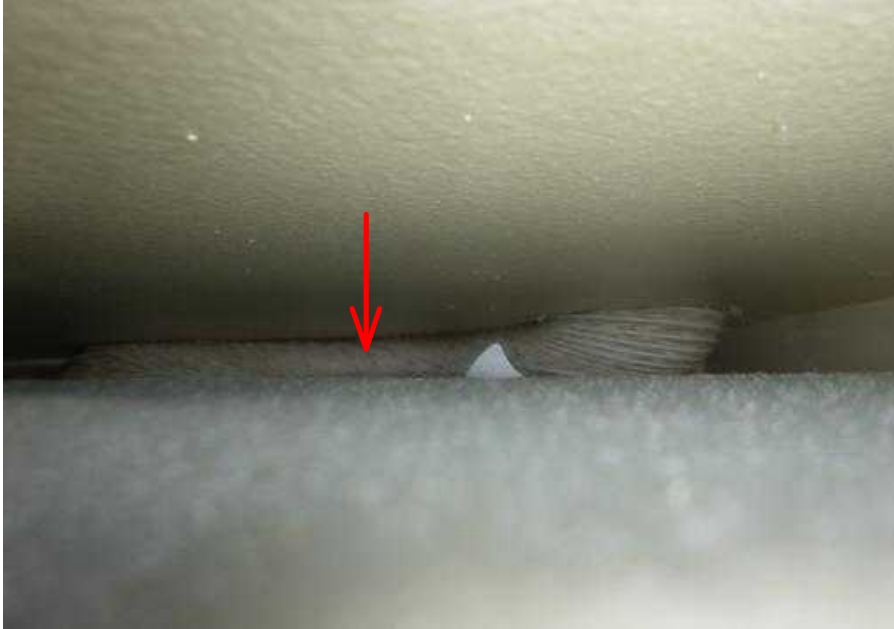
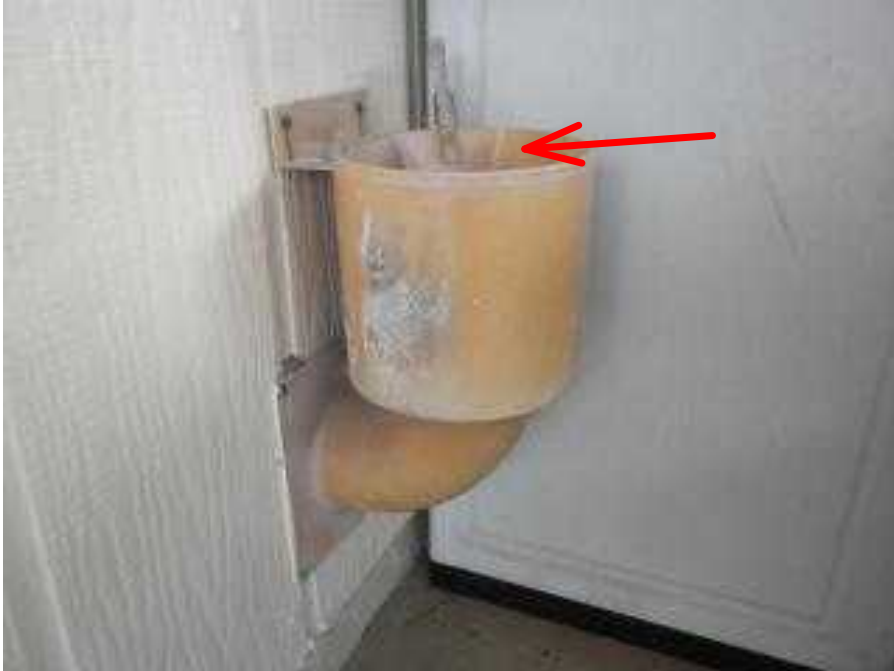
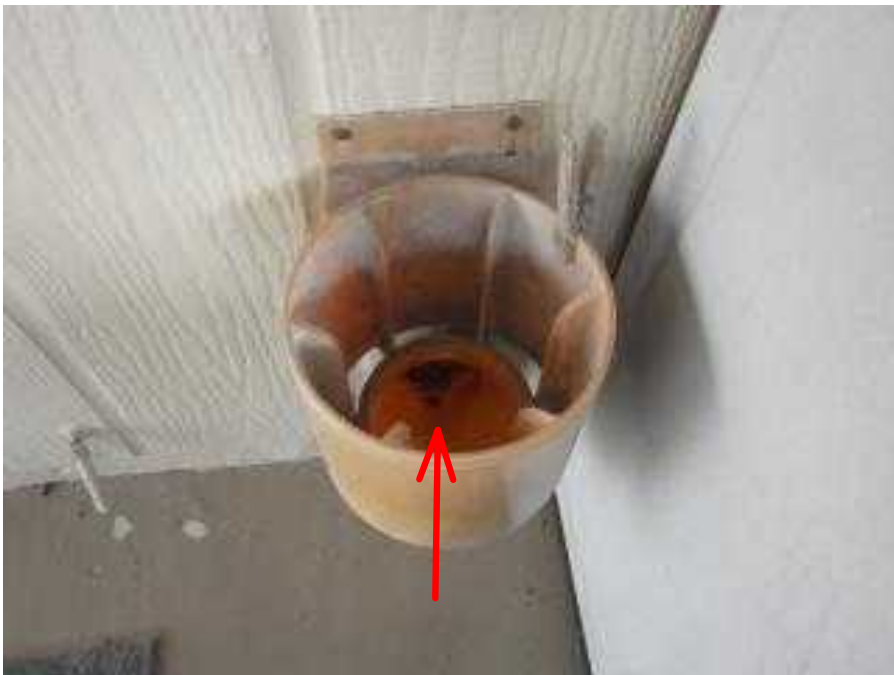
- 16. Carport Entrance hallway Laundry Room/Area Dryer Vent:** Plastic flex. Vent appears to be plastic and compressed behind dryer. Recommend replacing plastic flexible duct with a rigid or corrugated semi-rigid metal duct for maximum airflow. The US CPSC considers flexible ducts to be unsafe and a fire hazard. See www.cpsc.gov/CPSCPUB/PUBS/5022.html for further information. Additionally, the dryer vent termination on the exterior does not have a flap to prevent critter entry.

- Ceiling:** Popcorn ceiling
- Walls:** Painted drywall
- Floor:** Ceramic tile
- Doors:** Wood
- Electrical:** 110 VAC outlets and lighting circuits
- Smoke Detector:** Not present
- HVAC Source:** Heating / Cooling system register
- Washer** Roper
- Dryer** Roper
- Washer Hose Bib:** Gate valves
- Washer and Dryer Electrical:** 110-240 VAC
- Dryer Vent:** Plastic flex. Vent appears to be plastic and compressed behind dryer. Recommend replacing plastic flexible duct with a rigid or corrugated semi-rigid metal duct for maximum airflow. The US CPSC considers flexible ducts to be unsafe and a fire hazard. See www.cpsc.gov/CPSCPUB/PUBS/5022.html for further information. Additionally, the dryer vent termination on the exterior does not have a flap to prevent critter entry.
