Home Inspection Report

1234 S. Main Street
Anytown, FL 00000

Prepared for: Home Buyer

Prepared by: Sharp Home Inspections, Inc.
PO Box 20934
Bradenton, FL 34204

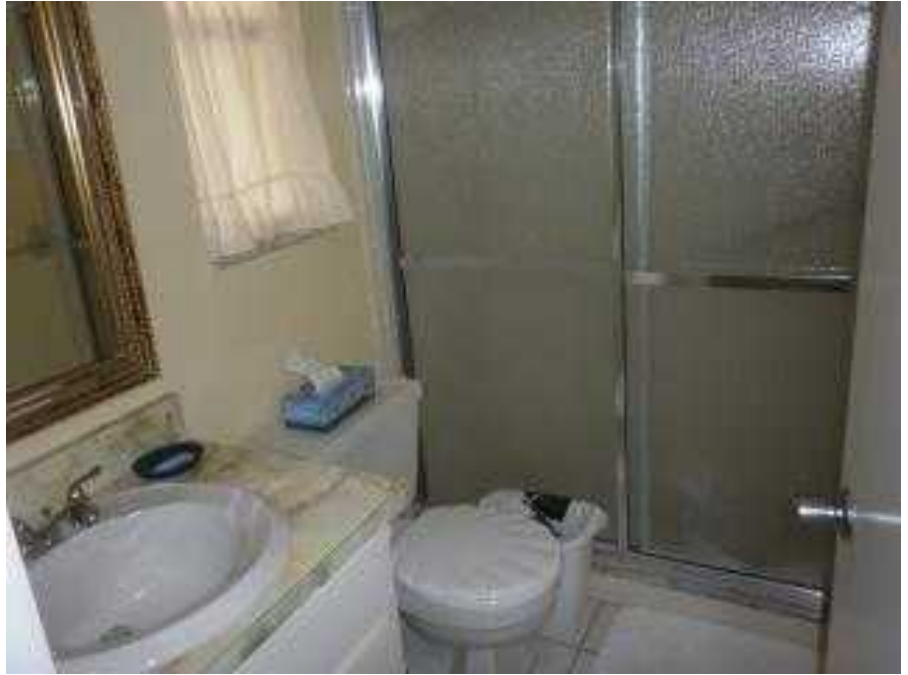
Bathroom 2 Photo

- 12. Bathroom 2 Bathroom Toilets:** Gerber. Leak at toilet tank when unit is flushed. Recommend repair by a licensed plumber.

- Ceiling:** Popcorn ceiling
- Walls:** Painted drywall
- Floor:** Ceramic tile
- Doors:** Hollow wood. [Striker plate missing at door.](#)

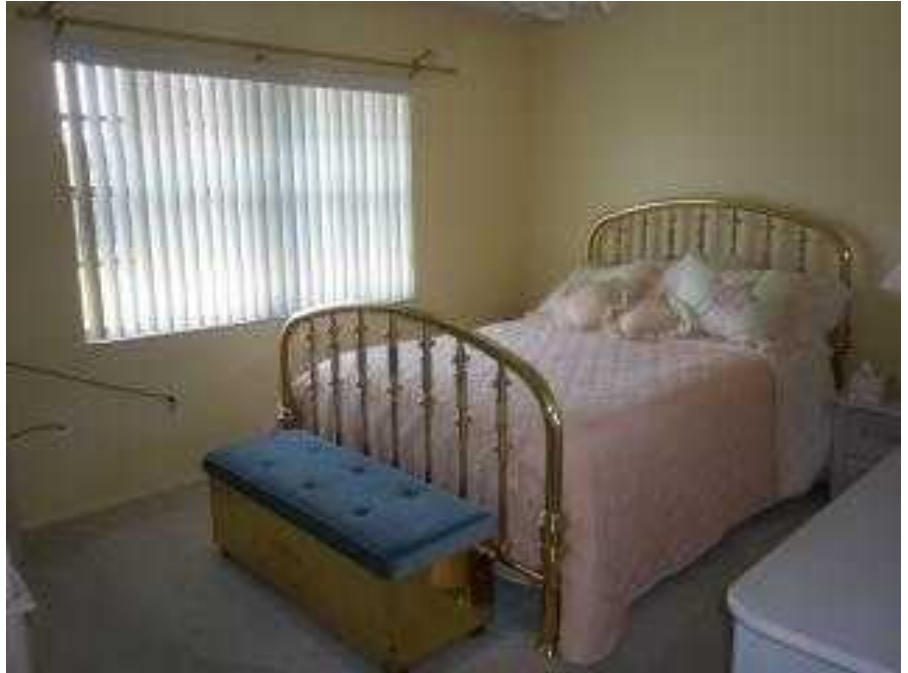
A NPNIM D
Master Bedroom Photo

Closet: Walk In. **Water stains** noted. No moisture present at the time of inspection.

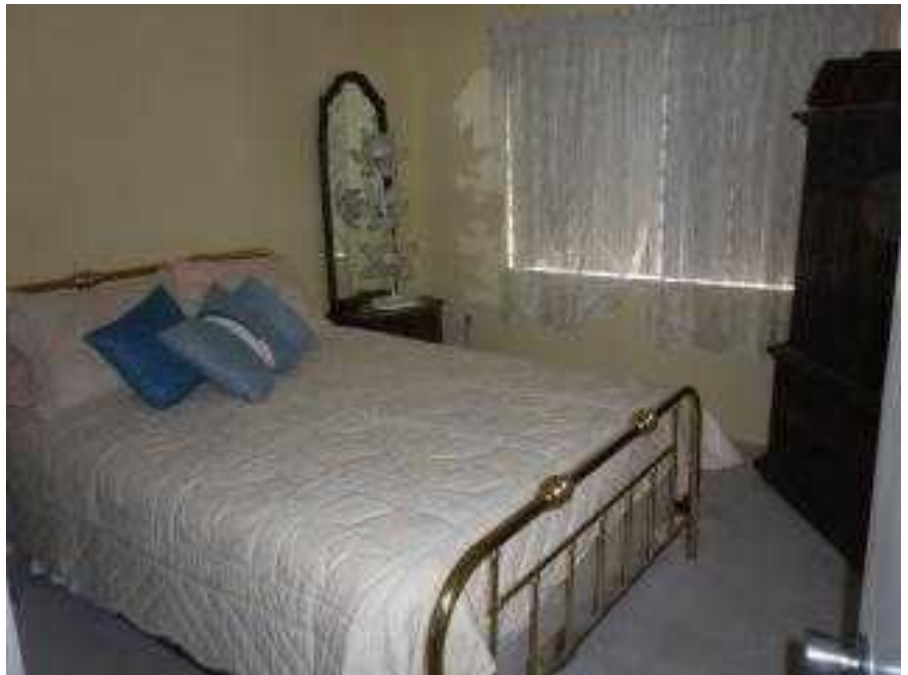
Bedroom 2 Photo

- 13. Master Bedroom Closet:** Walk In. Water stains noted. No moisture present at the time of inspection.
- 14. Bedroom 2 Bedroom Electrical:** 110 VAC outlets and lighting circuits. Ceiling light and a fan was inoperative, possibly bad battery in remote control. Recommend further evaluation by a licensed electrician.

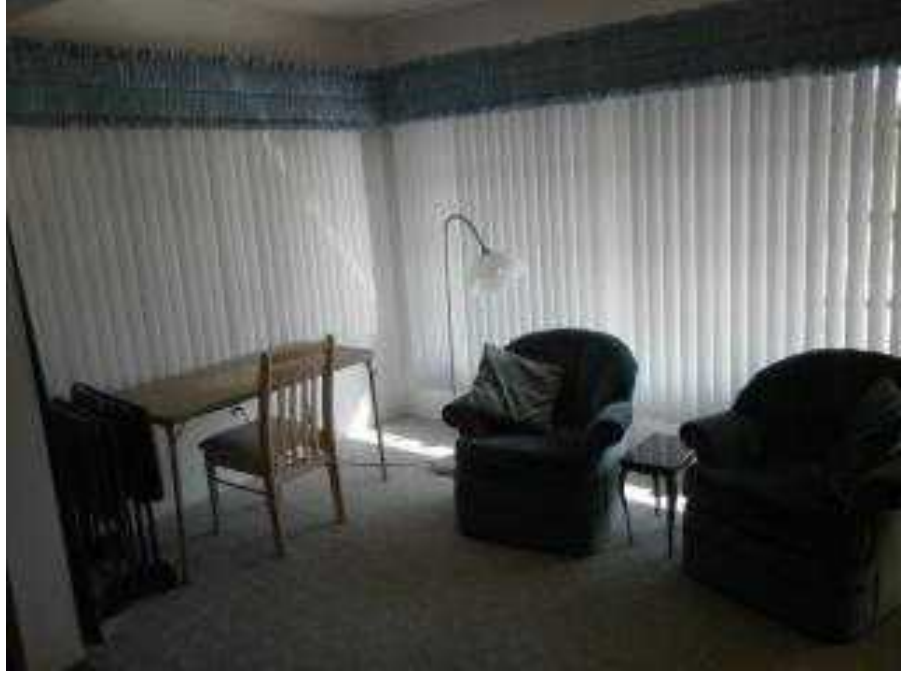
Den Photo

- 15. Den Living Space Electrical:** 110 VAC outlets and lighting circuits. Ceiling light fixture missing.

- Ceiling:** Popcorn ceiling
- Walls:** Painted drywall. *Minor hairline crack to south wall, above sliding glass door*

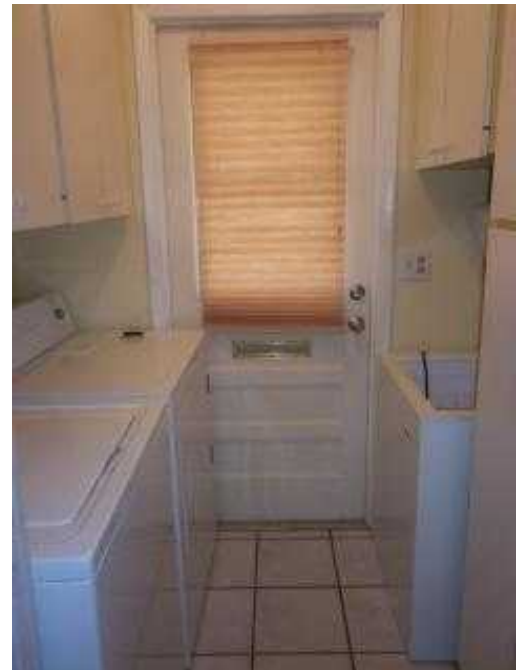
ANPNIM D
Laundry Photo

- 16. Carport Entrance hallway Laundry Room/Area Dryer Vent:** Plastic flex. Vent appears to be plastic and compressed behind dryer. Recommend replacing plastic flexible duct with a rigid or corrugated semi-rigid metal duct for maximum airflow. The US CPSC considers flexible ducts to be unsafe and a fire hazard. See www.cpsc.gov/CPSCPUB/PUBS/5022.html for further information. Additionally, the dryer vent termination on the exterior does not have a flap to prevent critter entry.
